# ANNUAL REPORT FOR 2015

**Turkey Branch Site J Mitigation Site**  
**Madison County**  
**TIP No. R-2518A**  
**COE Action ID: SAW-2007-2197-357/300**  
**DWR #: 20071134**

Prepared By:  
Natural Environment Section & Roadside Environmental Unit  
North Carolina Department of Transportation  
November 2015

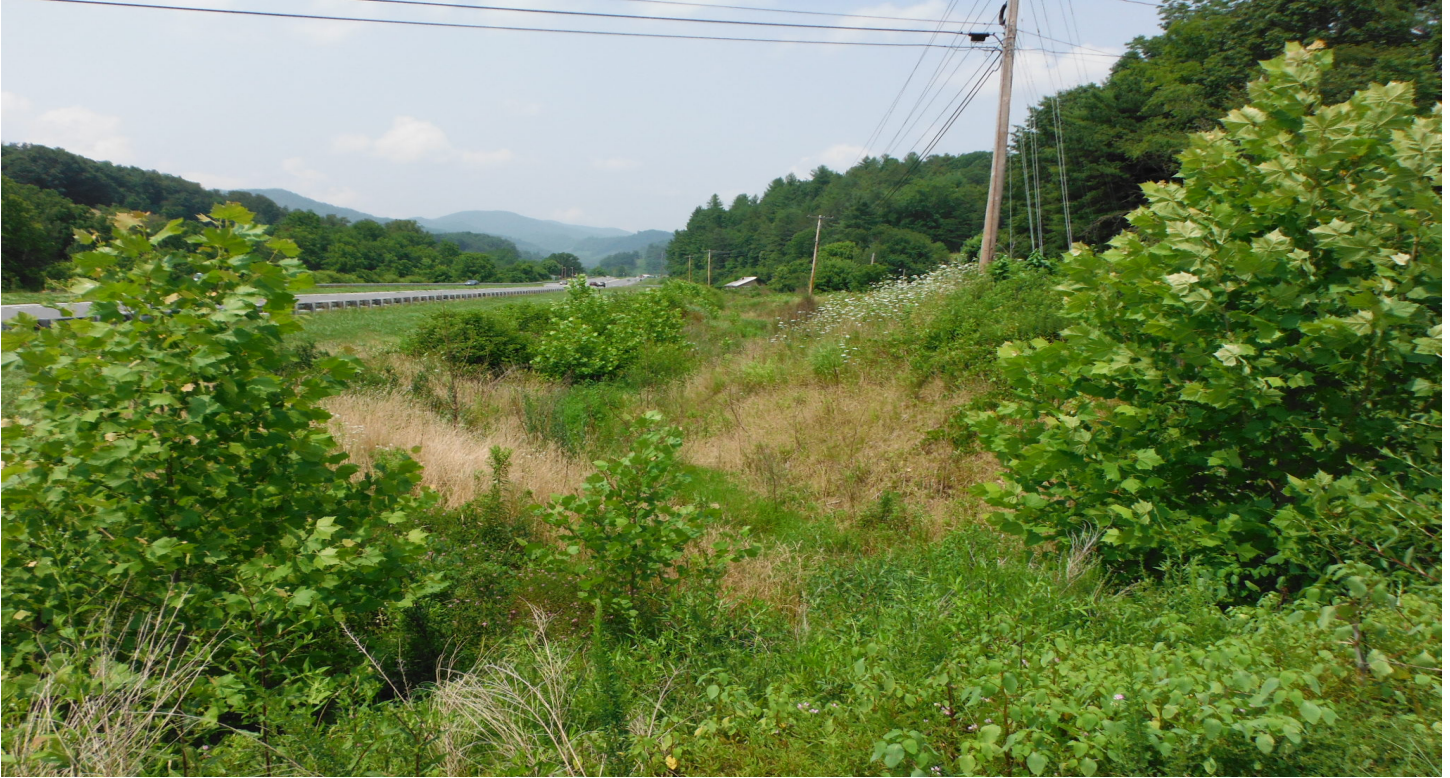
Vegetation Overview Photo (Looking upstream from culvert crossing)

**Streambank & Buffer Vegetation:** The streambank reforestation was completed in March 2012. The Year 4 vegetation monitoring evaluation noted: Type I: Black Willow, Silky Dogwood and Type II: Sycamore, Green Ash, Tulip Poplar and White Oak were surviving at the time of the monitoring evaluation.
